Fortune 100 Chemical Company Relied on The Hope Group For PLC Control Solution to Replace Pneumatic Logic System

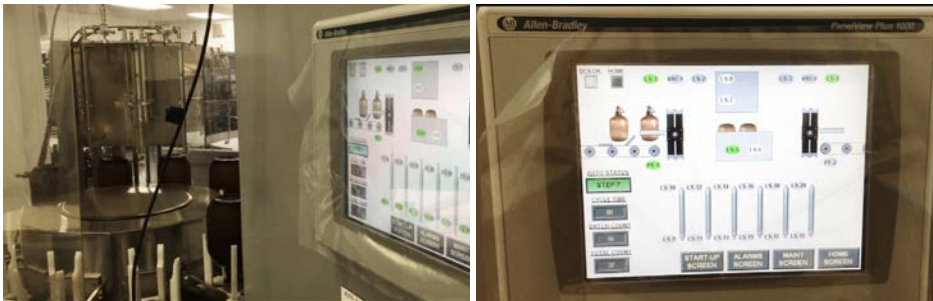
Monitoring System Processes

The Hope Group developed HMI screens that indicate which washing step the machine nearby is performing and monitors the control systems for the conveyer belts and bottle feeding system. The screen will also indicate when a washing sequence has been paused by the control system as a result of the water or nitrogen parameters falling outside their appropriate ranges.

The Hope Group developed HMI (Human Machine Interface) screens that command the system and provide the customer with system feedback. The HMI screens can also be useful for monitoring the system during normal operation as helpful messages will pop up indicating which washing step the machine is performing and the status of all feedback devices. The screen will also indicate when a washing sequence has been paused by the control system as a result of the water or nitrogen parameters falling outside their appropriate ranges.
